Manhole Inspection Summary

Manhole # S35II1020MH

Location Address: **304 WENDOVER**

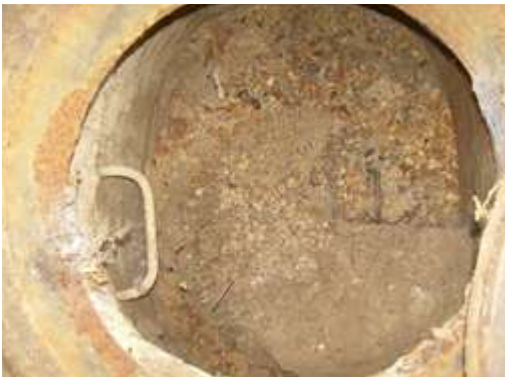
Top View

Channel debris.

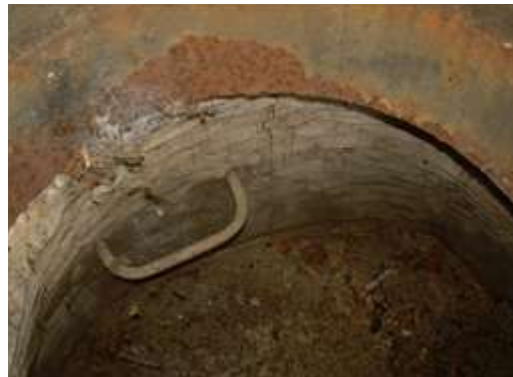
Defect

Corbel and Barrel infiltration.

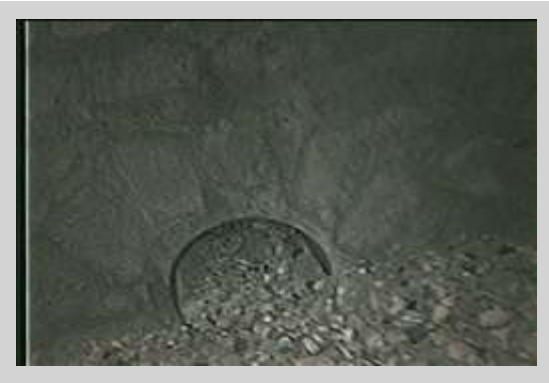
6 in. Circular Gravity Sewer Pipe Out @ 12 O'Clock

Deposits: ☐ None ☐ Mud ☐ Sludge ☒ **Debris** ☐ Grease

Silt Depth: **6** (in.) Deposits Extent: **Heavy**

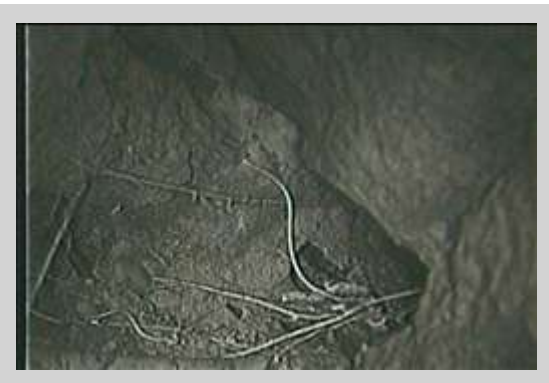
6 in. Circular Gravity Sewer Pipe In @ 4 O'Clock

Deposits: ☐ None ☐ Mud ☐ Sludge ☒ **Debris** ☐ Grease

Silt Depth: **0** (in.) Deposits Extent: **Light**
